## 1. INTRODUCTION

STS-74 launched on November 12, 1995, and was docked to the Mir Station from the 14<sup>th</sup> thru the 17<sup>th</sup>. The nine day mission ended with a KSC landing on November 20, 1995. This was the Shuttle's second docking mission and its third rendezvous with the Mir Station. Approximately 1030 photographs and 22 hours of video of the Mir Station were acquired during the mission. This report documents results from several survey-related analysis tasks.

### 1.1 Overview of Mir Photo/TV Survey

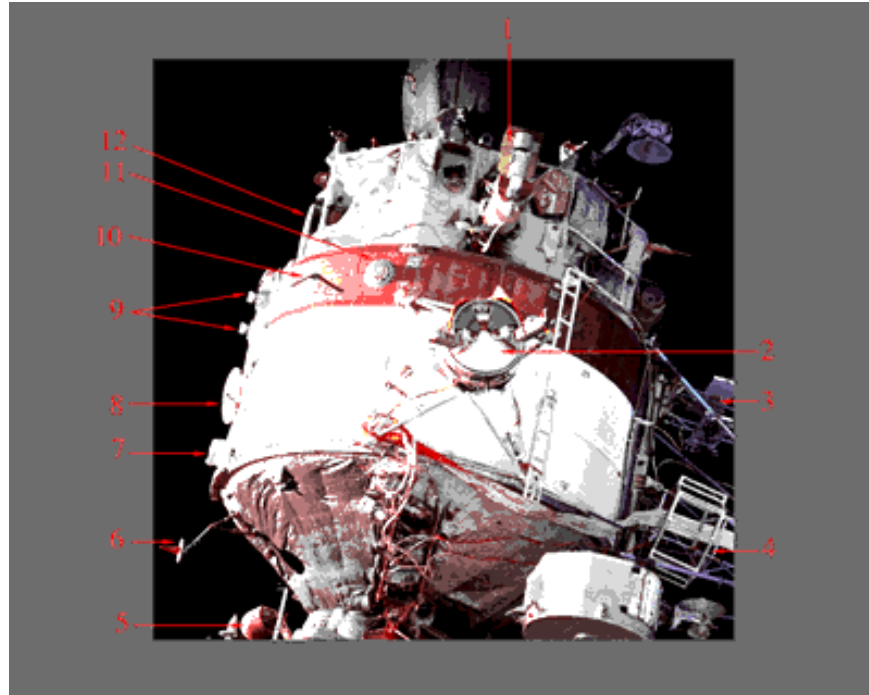
**Figure 2-A Kvant**

- 1. Astrosensor**
- 2. Solar Array Attach Port**
- 3. *Unknown***
- 4. Sofora Truss**
- 5. Approach & Rendezvous Antenna**
- 6. Igla Antenna**
- 7. Instrument for Visual Orientation on Stars**
- 8. Window Cover**
- 9. Horizon Sensors**
- 10. Radio Communication Antenna**
- 11. Infrared Sensor**
- 12. “Glazar” Telescope (edge-on view)**

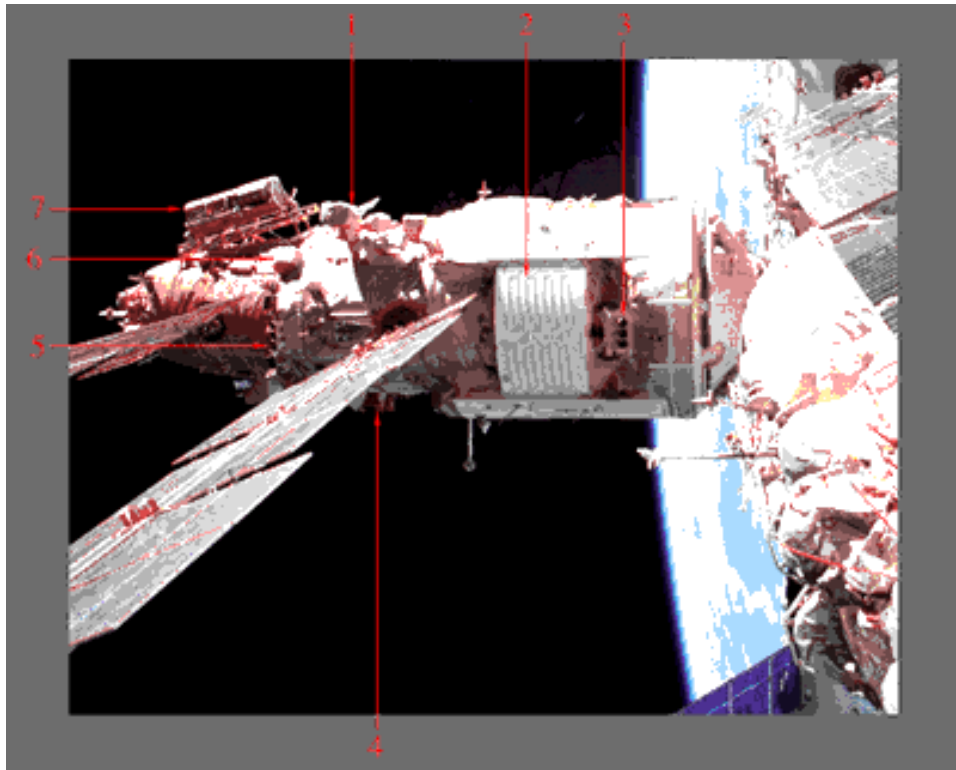
**Figure 2-C Spektr**

- 1. *Unknown***
- 2. Radiator**
- 3. Precision Attitude Control Thrusters**
- 4. Payload Pointing System**
- 5. Attitude Control & Docking Thrusters**
- 6. *Unknown***
- 7. *Unknown***

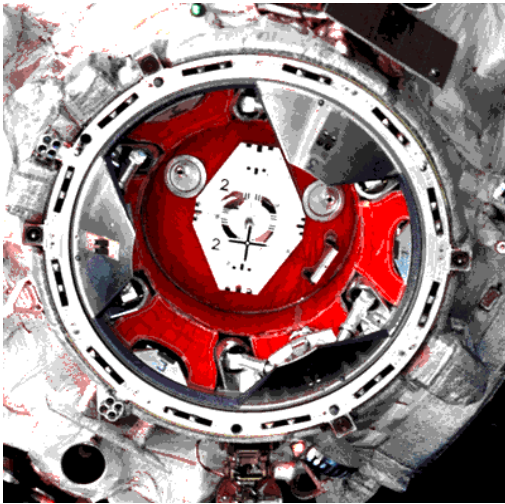
**Figure 4-A Hasselblad (Approach)**

Only a few still photographs of the docking mechanism area during approach were acquired. Figure 4-A shows the best of these images. Section 3 of this report documented backing material peeling off the target backplate. This image was taken early on during approach with the Hasselblad (70mm) camera.

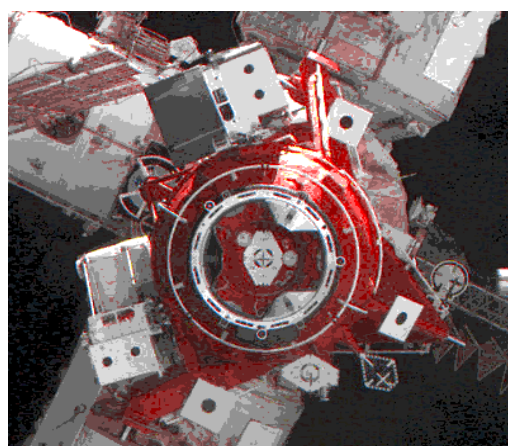
**Figure 4-D ESC (Backaway)**

Figure 4-D depicts one of the few available still images of the new Docking Module and associated targets during backaway. Note the OSVS targets surrounding the capture ring. This view also showed the bottom surfaces (identified with the double dot targets) of both

the Cooperative Solar Array (CSA) and the Russian Solar Array (RSA), both of which will eventually be installed onto the Kvant module.

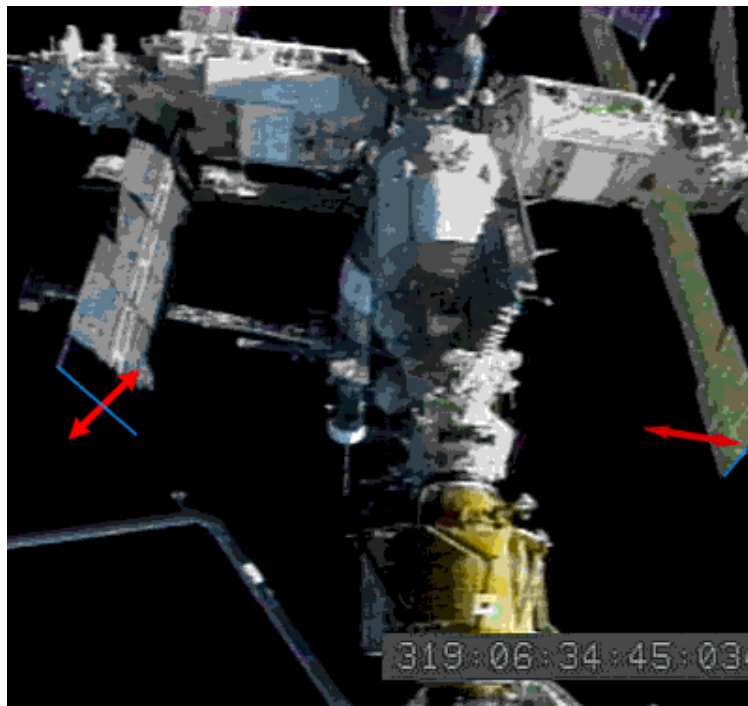
**Figure 5-A Camera B View Showing Kvant-2 / Spektr Array Motion**

Figure 5-A depicts the payload bay camera B view when the Kvant-2 SP#2 and Spektr SP#2 array motion was visible. Accompanying motion of the partially retracted SP#2 array on the Kristall module was evident by a change in the panel surface reflection. However, this latter motion was too difficult to quantify.

Figure 5-B shows motion of the two different arrays as a function of GMT time. The corresponding frequency of oscillation plots are contained in Appendix D. Analysis of this motion indicated a maximum peak-to-peak magnitude of about 7.5 inches for the Kvant-2 array and almost 2 inches for the Spektr array (+/- 0.5 in.), both with a dominant frequency of 0.2 Hertz.

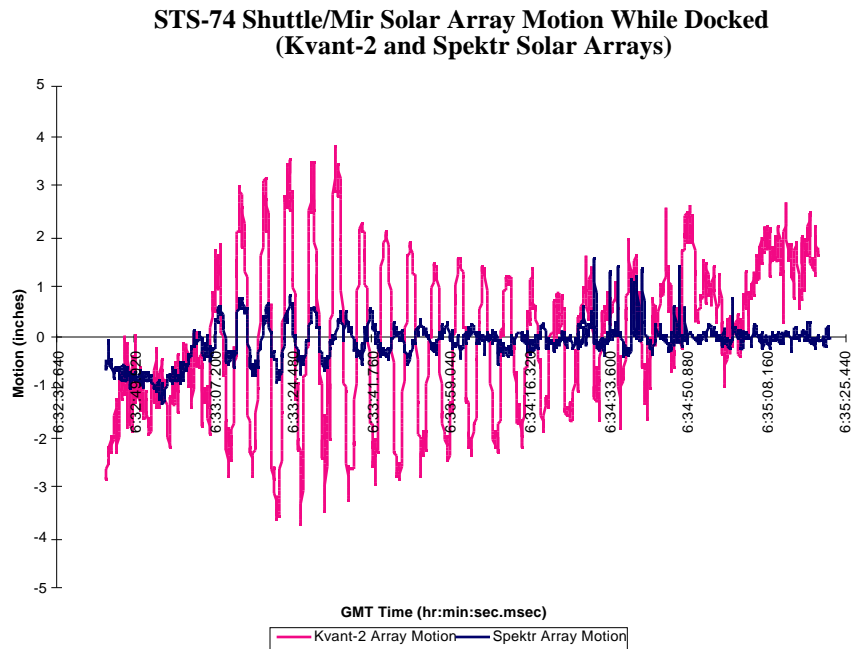
**Figure 5-B Kvant-2 / Spektr Array Motion as a Function of GMT**

Figure 5-B shows that the motion was visible for nearly two minutes. A common dominant frequency of oscillation is identifiable in the motion chart and was borne out in the frequency analysis. The existence of a lower frequency is suggested in the damped sinusoidal pattern, but none was identifiable in the frequency plot located in Appendix D.

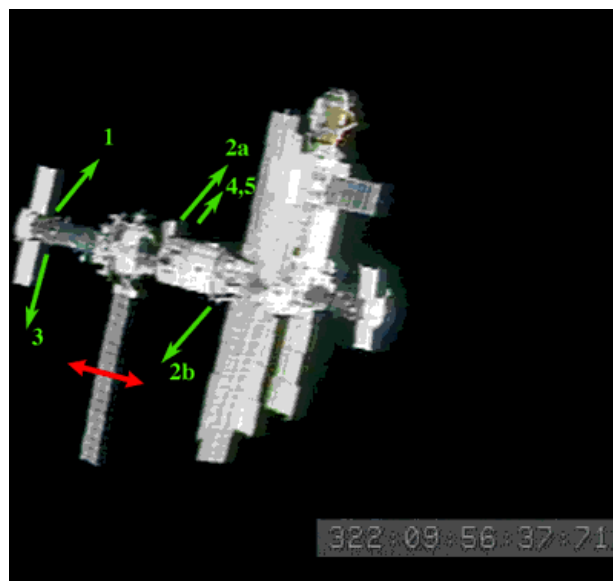
**Figure 5-E Camera D View Showing Kvant Array Motion**

Only one array motion event was seen outside the docked phase. The Kvant SP#1 array flexed during the early part of fly-around at 322:09:56:30. This motion was preceded by a visible sequence of firings from Progress and Base Block thrusters as identified in Figure 5-E. The sources and apparent direction of these firings are also plotted on the timeline in Figure 5-F.

Figure 5-E shows the camera D view used to document motion of the Kvant SP#1 array during fly-around. The orange arrow indicates maximum motion occurred at the center of the array. And unlike the other types of motion documented on this mission, the Kvant array appeared to flex, perhaps displaying torsion. Whether this motion could be attributed solely to plume impingement or by forces induced by Mir thruster firings could not be verified. The maximum peak-to-peak amplitude of motion was measured to be about 24 inches (+/- 6 inches). The error term is a function of the measurement accuracy of features that are a significant distance from the camera and only comprise a few pixels on the digitized video.

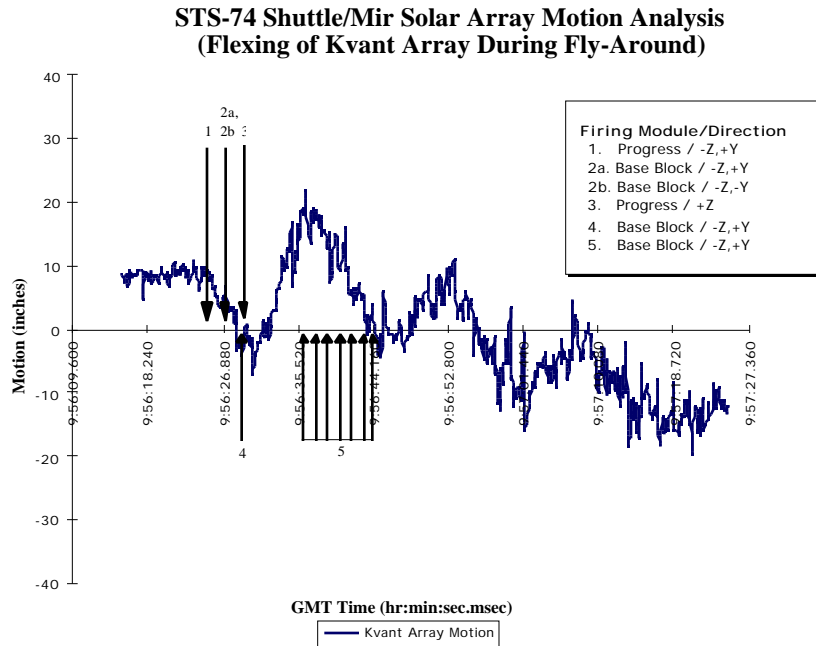
**Figure 5-F Kvant Array Motion as a Function of GMT**

Figure 5-F characterizes the motion of the Kvant array after Mir thruster firings. There appeared to be three distinct oscillations of the array during the sequence. These oscillations may be the source of the lowest frequency peak of 0.065 hertz, with an additional peak noted at 0.65 hertz. Appendix D contains the frequency plot generated from this data.

Figure 5-F documents the array motion as a function of time. Mir thruster firings and their direction (in Mir coordinates) seen around the time of motion are included in the graph. Note that the documented firings are just those that were visible and are not necessarily comprehensive. The downward-pointing arrows on the graph denote major pulses from the specified thrusters. The smaller, upward-pointing arrows identify what appeared to be minor pulses that may have contributed to the motion. The corresponding frequency plot is located in Appendix D.

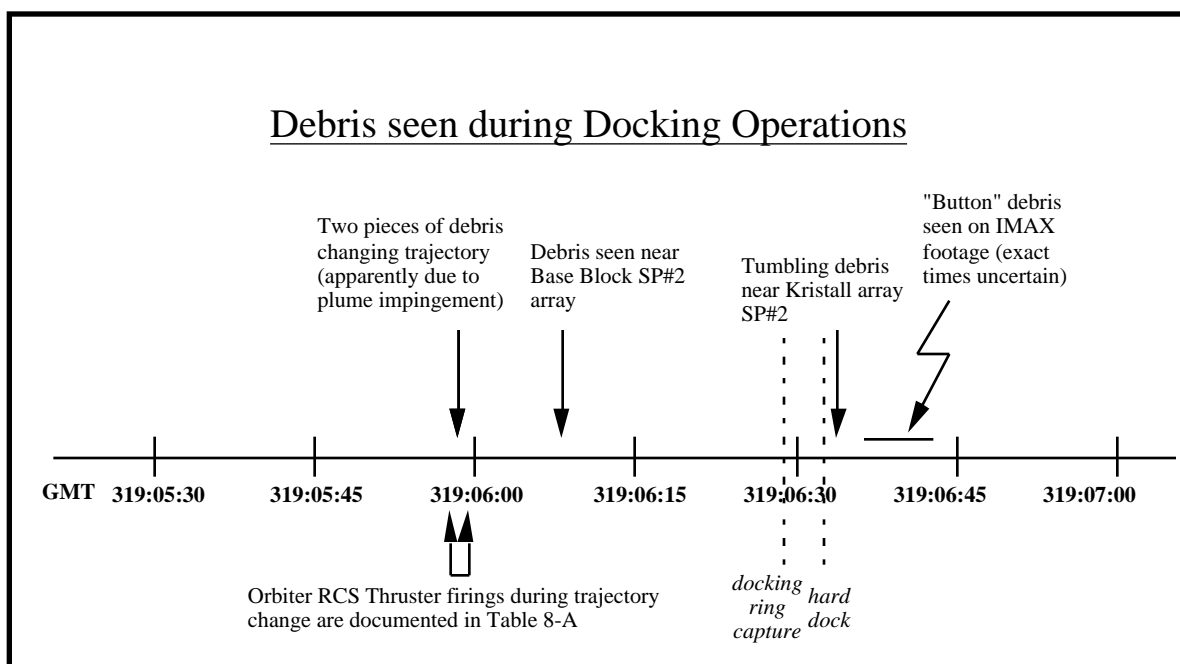
**Figure 8-A Debris Timeline During Docking Operations**

Figure 8-A documents the specific debris “events” which were characterized in this analysis. One cluster of debris (made more visible due to lighting conditions) was seen during a three minute interval starting approximately thirty minutes before soft dock. Thirty-two small pieces of light colored debris were noted between the Orbiter and the Mir Station. Two of these pieces were deflected from their initial trajectory by what appeared to be an interaction with unseen plumes. Ten minutes later, a zoomed-in view from camera B showed a piece of debris near the Base Block SP#2 array. Just after docking, nine small pieces of debris were seen coming from the vicinity of the payload bay and traveling up toward the Station. One of these pieces appeared to follow a curvilinear path past the Kristall array. Also, IMAX footage revealed a button-like object bouncing within the payload bay several minutes after docking.

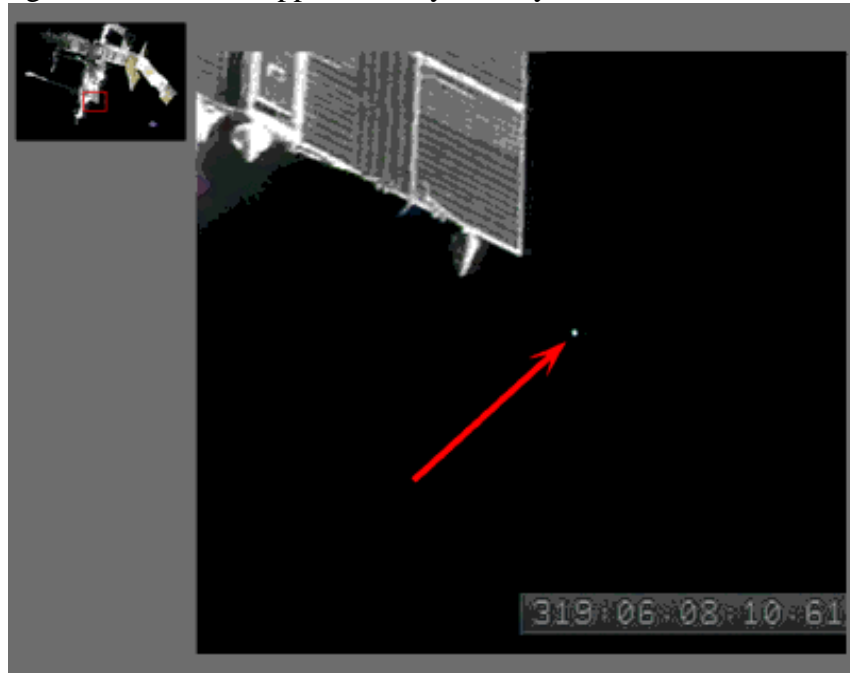
**Figure 8-C Debris seen near Base Block SP#2 Array During Approach**

Figure 8-C shows one small piece of light-colored debris near a Base Block SP#2 array twenty minutes before docking. The particle traveled up in front of the array before exiting the camera's field-of-view. Its maximum width was estimated to be less than an inch in size.

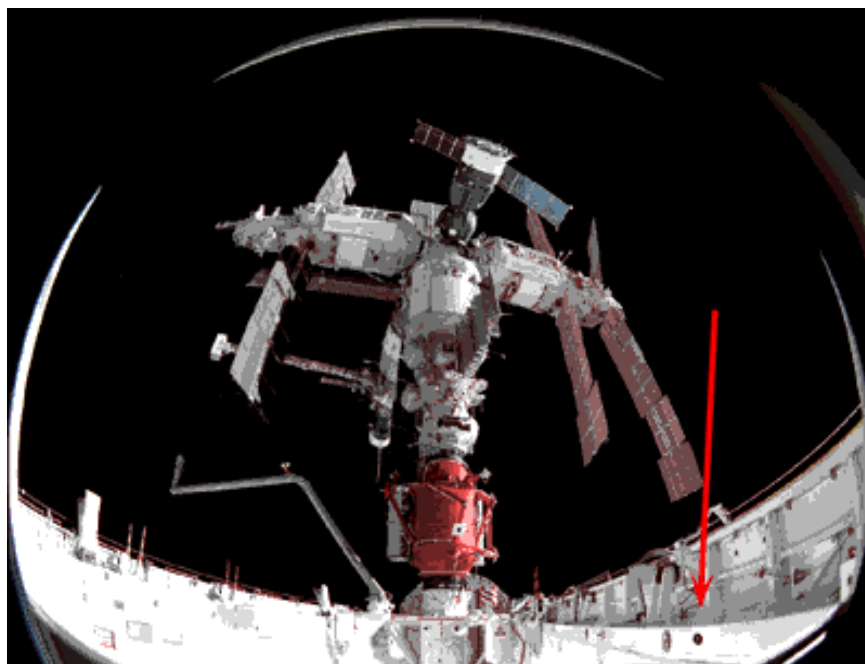
**Figure 8-E IMAX view of Button Debris shortly after Docking**

IMAX footage revealed this piece of debris (identified as a button used to fasten thermal blanket material) bouncing within the confines of the payload bay several minutes after docking. Figure 8-E shows this debris after it appeared to travel from the forward section of the payload bay to the rear. After hard dock, nine other pieces of small light colored debris were seen traveling up toward the Station. None were seen to make contact with Station surfaces while within the camera field-of-view.
